Managing old sheep dip and footbath sites: a guideline for landowners

Environment Canterbury has prepared this fact sheet to assist owners to identify and manage the risks associated with old dips and footbaths as a result of its recent work on sheep dip sites in the Canterbury region.

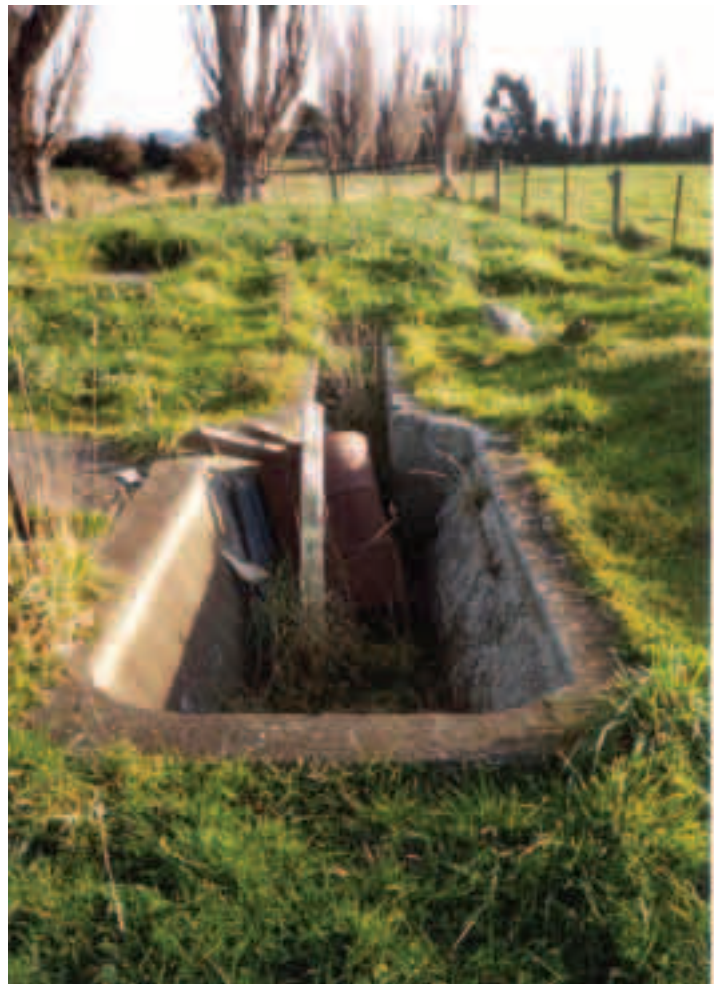
Old sheep baths can still be found on many farms

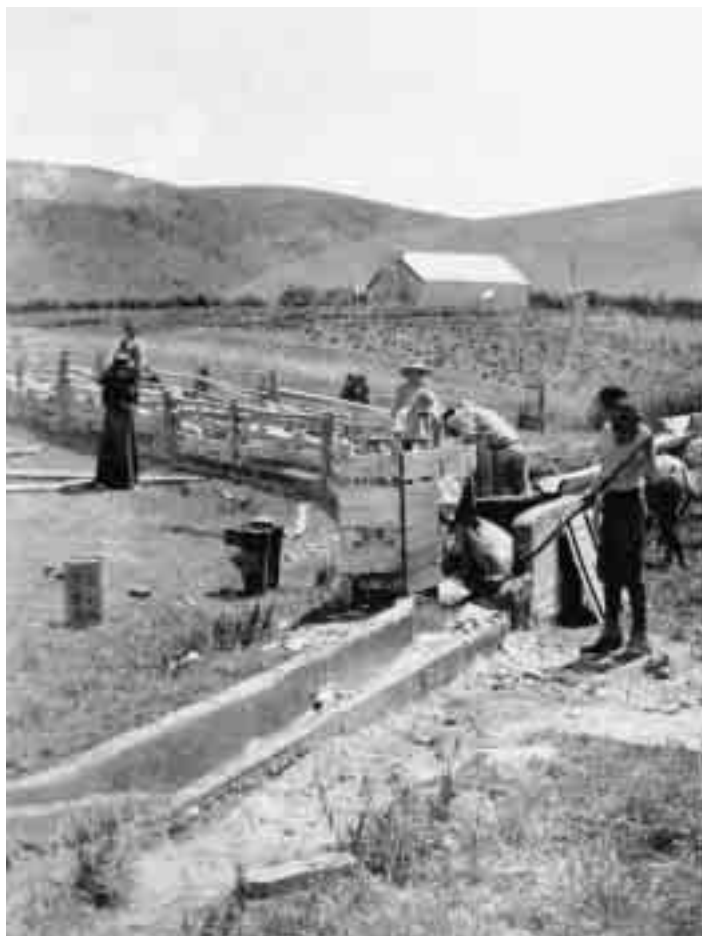
Below: Broken remains of an old sheep dip site

neighbours to help locate the historic sheep dip, draining platform or footbath structures. Previous owners may have filled in dip sites or broken up concrete bunding. However, there may be remains or signs of past activities. Common evidence includes broken concrete rubble, depressions in the ground (where plunge dips might have been filled in), and large concrete pads set in the ground.
