TECHNICAL REPORT Investigations and Monitoring Group

Sediment quality at muddy intertidal sites in Canterbury

Report No. R12/33 ISBN 978-1-927210-21-5 ISBN 978-1-927210-22-2 (web)

December 2012

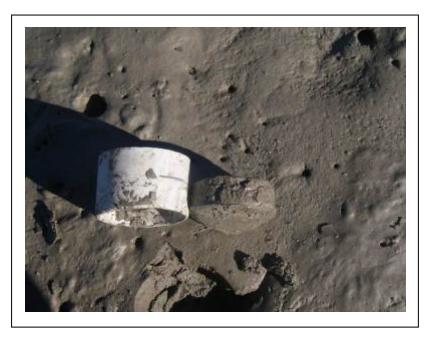
Figure 2-3: The PVC pipe and a surface sediment sample

To collect our samples, we used a 5 cm high by 2.5 cm diameter polyvinyl chloride (PVC) pipe with 2 cm clearly marked (Figure 2-3) and a stainless steel knife. We cleaned the knife and PVC pipe between each sampling site but not between each sample within a site.
