Yaldhurst Air Quality Monitoring

22 December 2017 – 21 January 2018

9 February 2018

Prepared for
Environment Canterbury

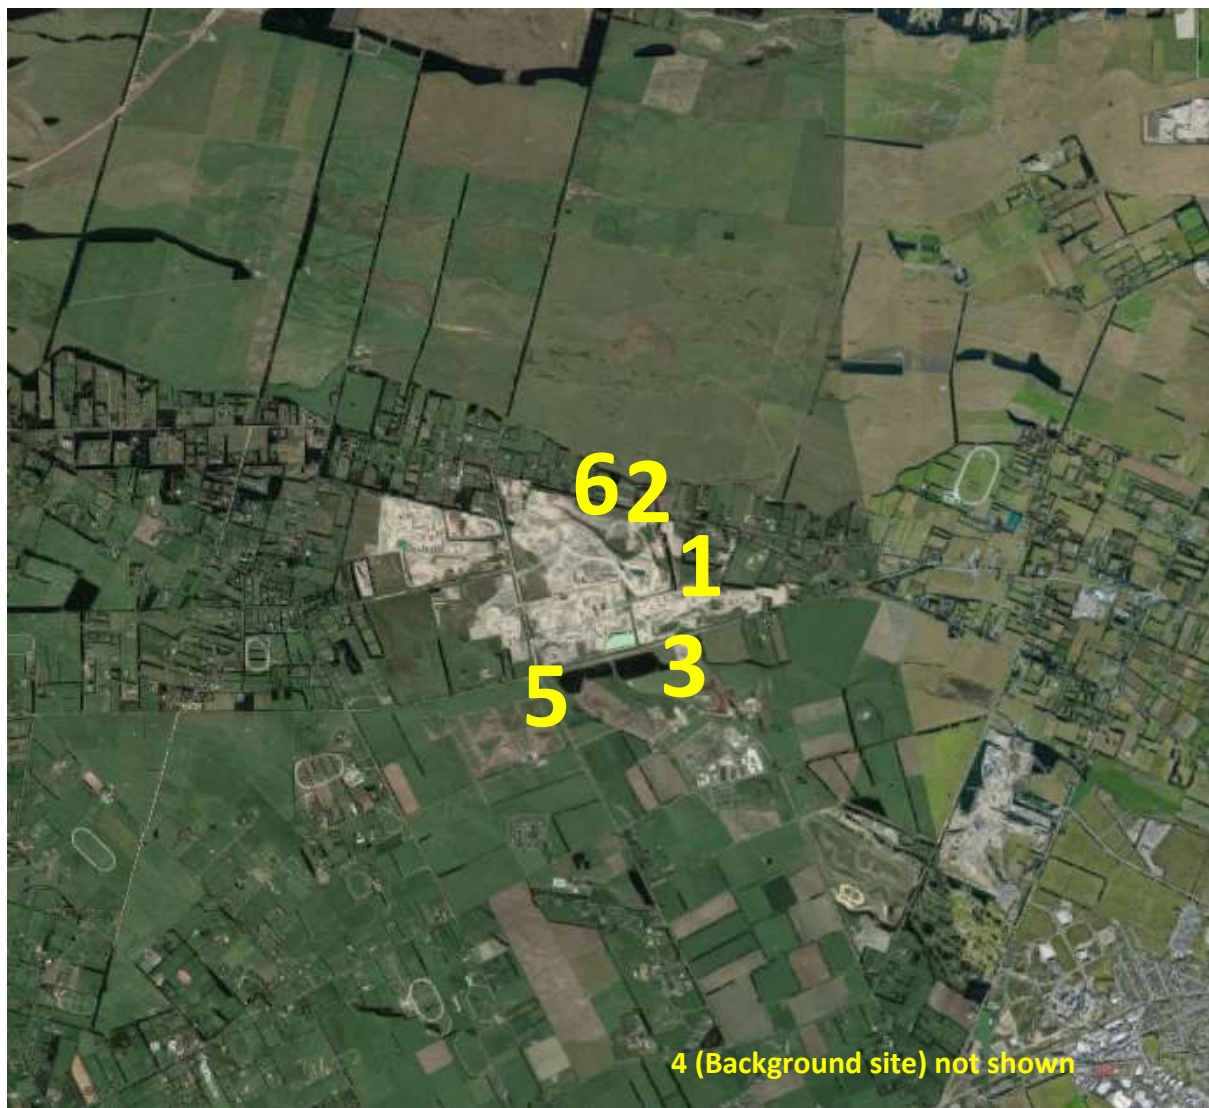
Figure 1 Indicative (only) locations of monitoring sites

- **Site 3: South (east)** – rural location a few hundred metres in the prevailing wind direction to the south east of the quarries
- **Site 4: Background** - background (rural/residential) location
- **Site 5: South (west)** - rural location a few hundred metres to the south west of the quarries
- **Site 6: North (west)** - rural/residential location a few hundred metres to the north of the quarries

The sites general locations are in **Figure 1**.

On 22 January 2018, we notified Environment Canterbury that this site was non-functional and received approval to relocate the nephelometer and RCS monitoring to a new site as soon as possible. The new Site 6A is sufficiently close (< 300 metres) that the location for Site 6 shown in **Figure 1** is still indicative.

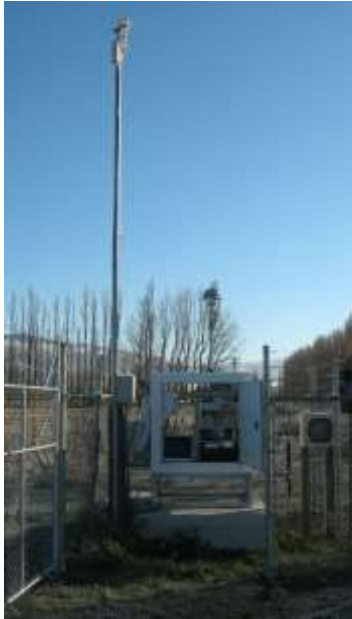
Figure 3 An example of a temperature controlled BAM enclosure with the doors open to illustrate the BAM inside

A Beta Attenuation Monitor or BAM is a widely used air monitoring technique employing the absorption of beta radiation by solid particles extracted from airflow. We are using Thermo FH52 C14 beta attenuation monitors inside temperature-controlled enclosures. These are located at Site 2 (to the north of the quarries) and Site 4 (background site).

Figure 3, which follows, shows a typical BAM installation.

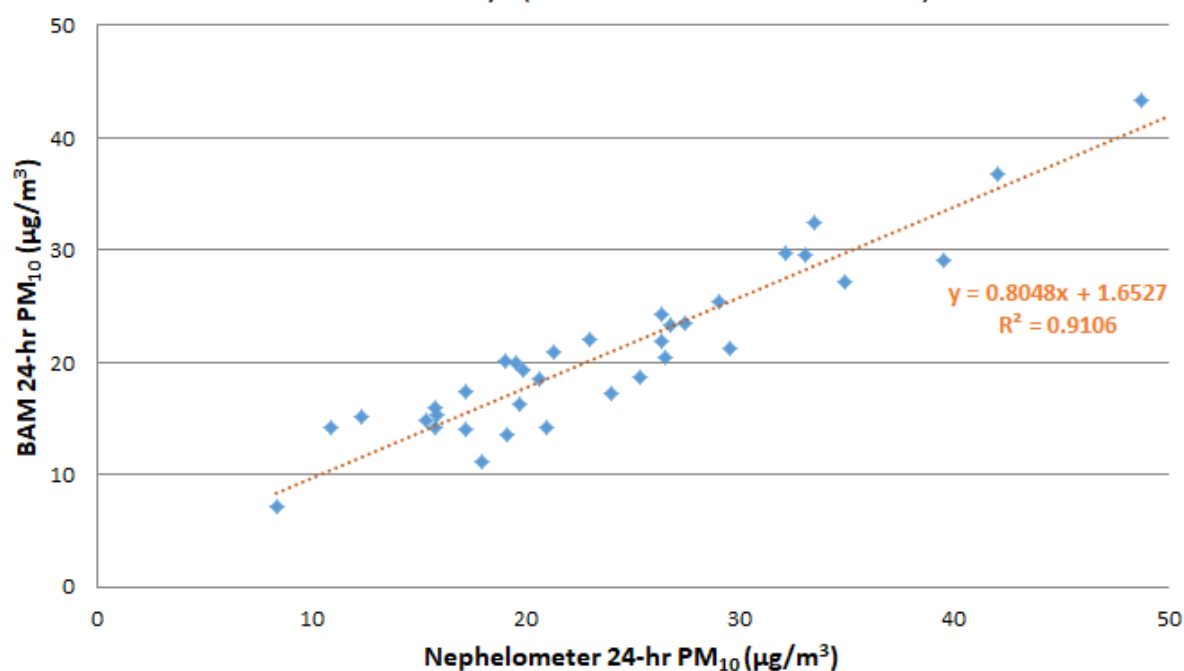
Figure 20 Daily PM₁₀ measured by nephelometer as a function of daily PM₁₀ measured by BAM at Site 4: Background rural/residential for (validated data) period 16 Dec 2017 – 23 Jan 2018

Figure 20 presents PM₁₀ measured by BAM as a function of PM₁₀ measured by nephelometer for available validated days of data at Site 4. This correlation suggests the nephelometer is over-reading actual PM₁₀ levels when compared with the reference method.
