# Yaldhurst Air Quality Monitoring

22 January – 21 February 2018

## Report 2

Prepared for  
**Environment Canterbury**

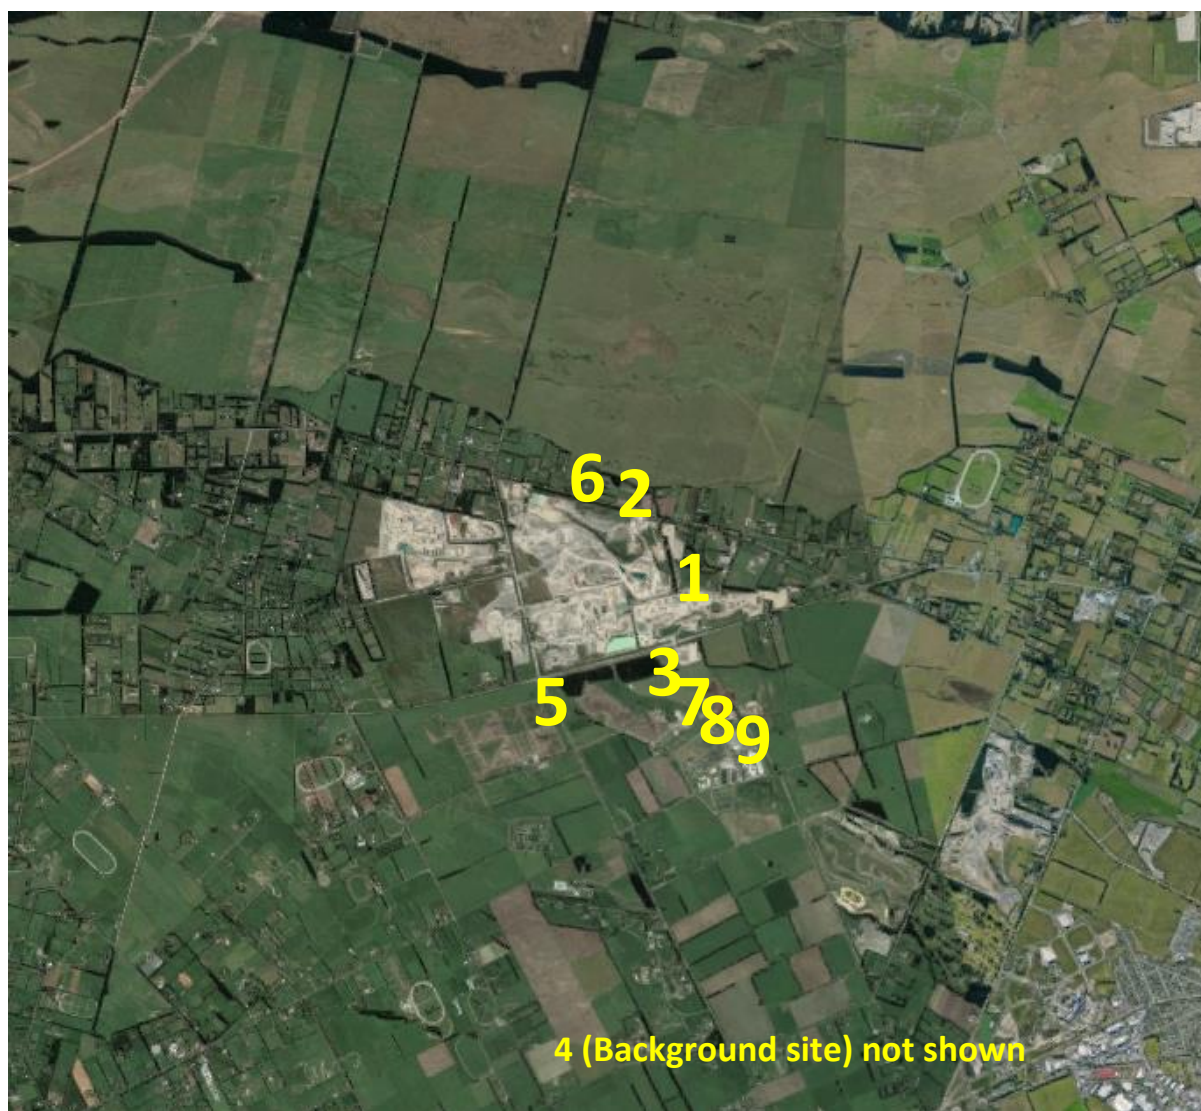
Figure 1 Indicative (only) locations of monitoring sites

The sites general locations are in **Figure 1**.

On 22 January 2018, we notified Environment Canterbury that this site was non-functional with respect to connectivity and received approval to relocate the nephelometer and RCS monitoring to a new site as soon as possible. The new Site 6A is sufficiently close (< 300 metres) that the location for Site 6 shown in **Figure 1** is still indicative.

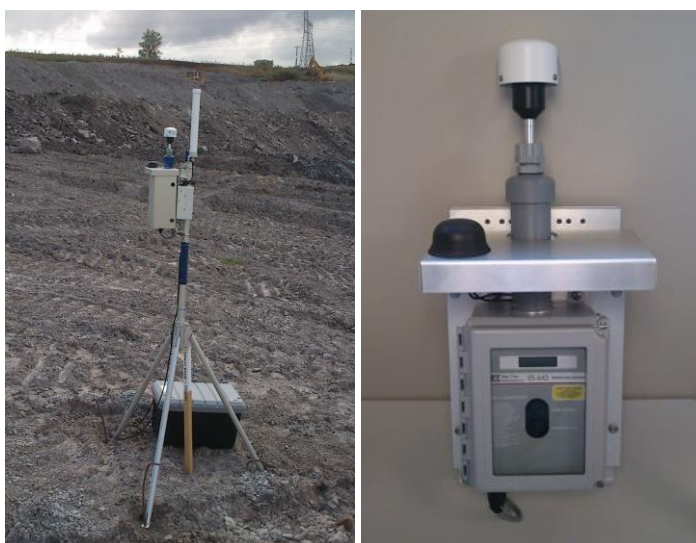
Figure 2 Typical nephelometer installations. The unit on the left is mains powered, while the unit in the centre is battery powered. The unit on the right provides a close up.

We have installed the nephelometers on poles and tripods at heights of between 1.5 and 2 metres above ground level. Excepting Site 2 and Site 4 (which are connected to mains power), the remainder of nephelometers are powered using a 12 volt battery which itself is charged using solar panels. To assist with smooth site operation and data interpretation, we have mounted ultrasonic wind sensors on poles alongside the nephelometers.

**Figure 2**, which follows, illustrates the types of nephelometers we have deployed around the Yaldhurst quarries.

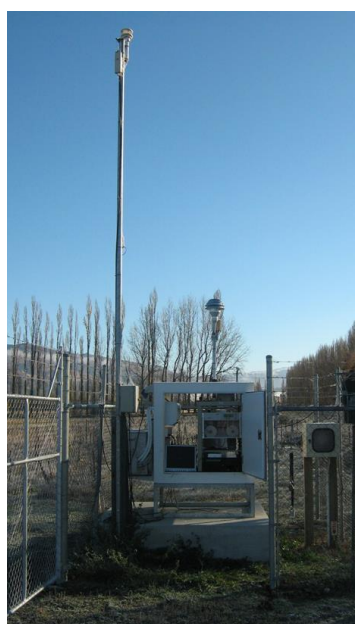
Figure 3 An example of a temperature controlled BAM enclosure with the doors open to illustrate the BAM inside

A Beta Attenuation Monitor or BAM is a widely used air monitoring technique employing the absorption of beta radiation by solid particles extracted from airflow. We are using Thermo FH62 C14 beta attenuation monitors inside temperature-controlled enclosures. These are located at Site 2 (to the north of the quarries) and Site 4 (background site).

Figure 3, which follows, shows a typical BAM installation.

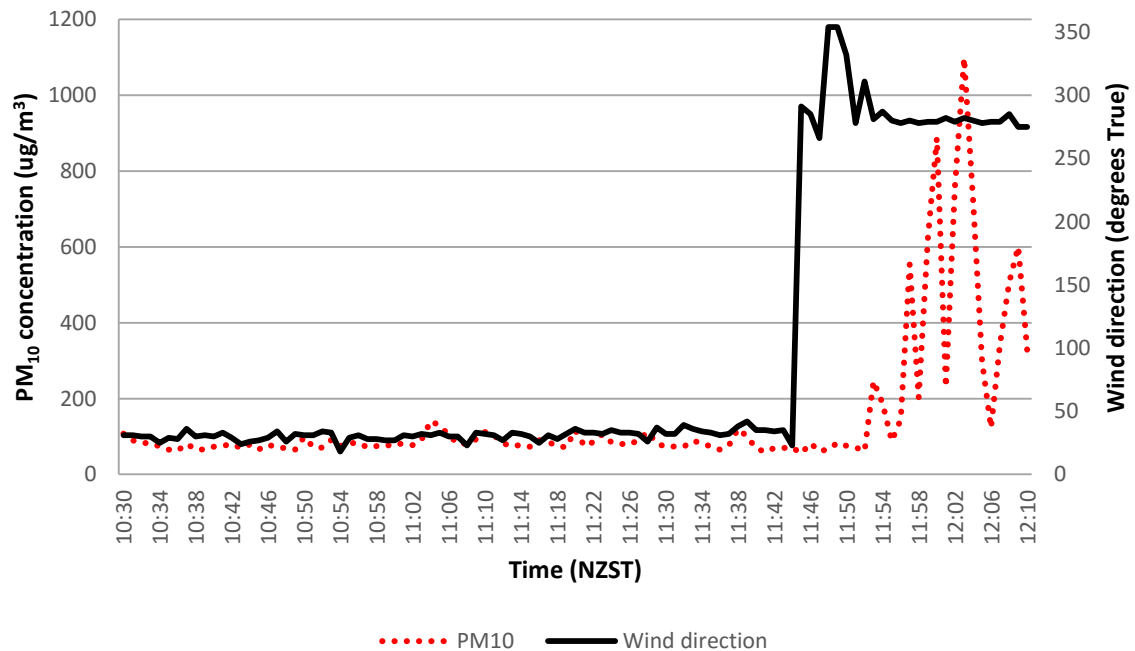
Figure 15 One minute PM<sub>10</sub> (nephelometer) and wind direction at Site 3: South (east) rural on 1 February 2018 during an exceedance event.

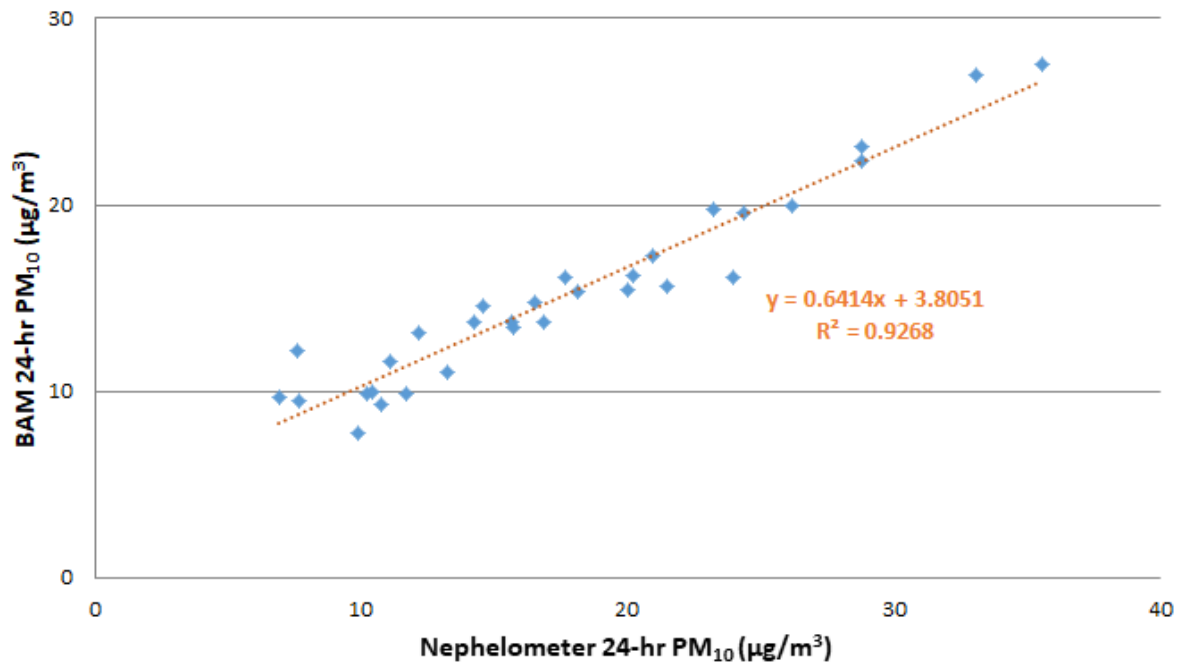
Figure 21 Daily PM<sub>10</sub> measured by nephelometer as a function of daily PM<sub>10</sub> measured by BAM at Site 4: Background rural/residential for (validated data) period 22 Jan - 21 Feb 2018

**Figure 21** presents PM<sub>10</sub> measured by BAM as a function of PM<sub>10</sub> measured by nephelometer for available validated (30) days of data at Site 4. This correlation suggests the nephelometer is over-reading actual PM<sub>10</sub> levels when compared with the reference method.

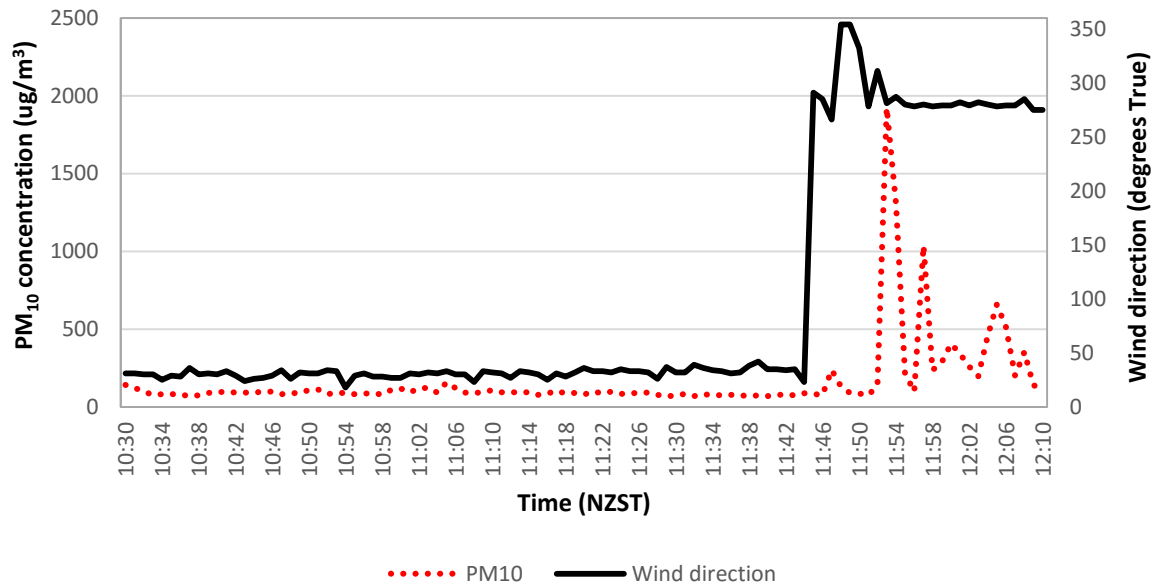
Figure 25 One minute PM<sub>10</sub> (nephelometer) and wind direction at Site 5: South (west) rural on 1 February 2018 during an exceedance event.
